2020 Solar Report from Maine

Written by Administrator Tuesday, 31 December 2019 17:14 - Last Updated Saturday, 02 January 2021 20:28

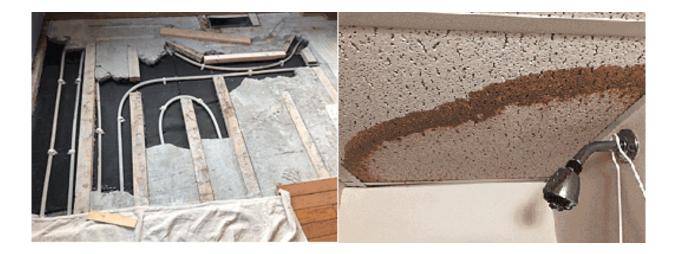
The biggest challenge this year was to determine why our radiant floor heat was misbehaving. The tubing that carries the solar-heated water from our basement storage tanks was taking on air, thus bringing the circulation to a halt. Was there a leak in the tubing embedded in the concrete subfloor? Workmen from the company that built our home some 26 years ago took on the challenge. I noted some stain spots on the oak flooring that might indicate the location of the leak.

So it was necessary to rip the flooring up and chip through the concrete to expose the tubing to find the leak. Alas, there was no leak in the floor. One of the workmen discovered stained ceiling tiles in the basement and the source was discovered to be a first floor manifold that

distributes heat to several sections of the house. All that was needed was to tighten the retaining clip on one of the connections and it was fixed, some \$6,000 later! Twenty-six years and still the house outperforms any conventional structure - that's a marvel!
